## CONCERNS

Worst point; the patient was told this was the best that could be done for her!

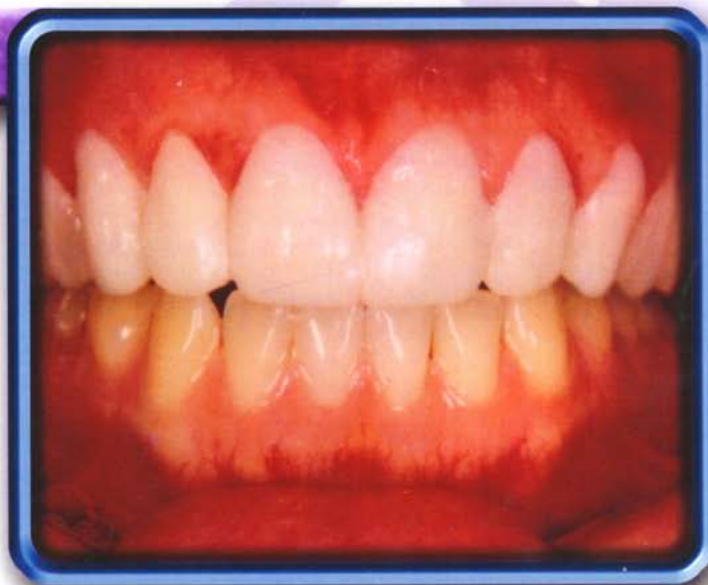
This will give the patient an opportunity to test drive her new smile.

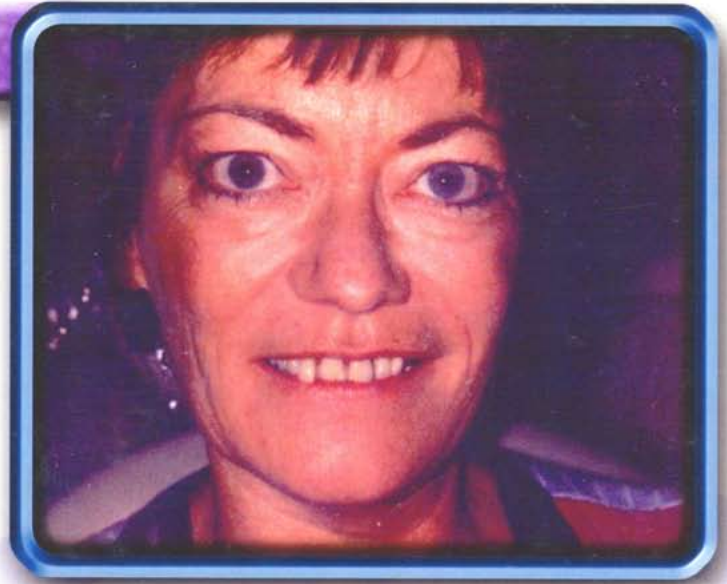
Loose, crooked, dark yellow/brown color. This patient was told she would be losing all her teeth. Notice the patient's expression.

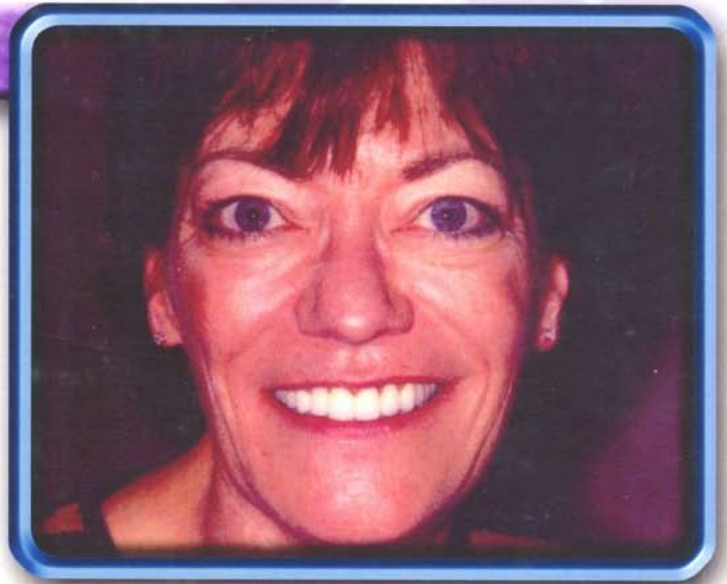
Conventional as well as advanced laser treatment techniques to stabilize teeth, placement of 14 ceramic units. Notice how engaged the patient's expression is.

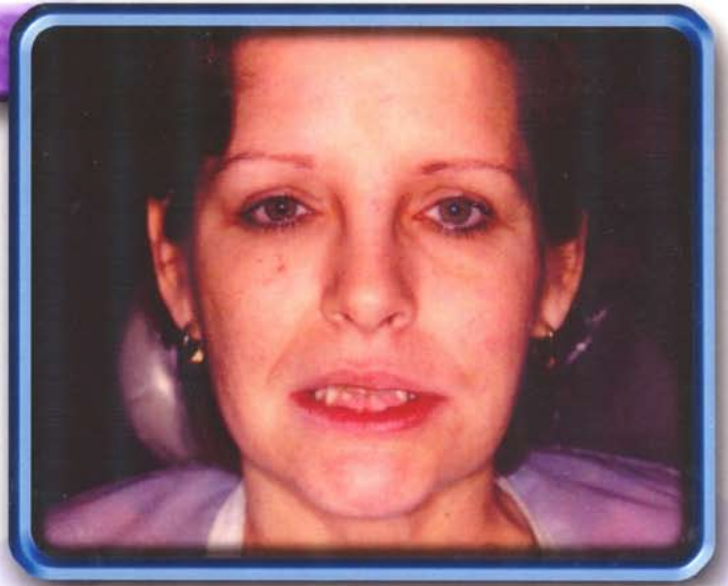
Broken down teeth, worn, decayed and out of position. Notice the patient's eyes, lines around her mouth and face.

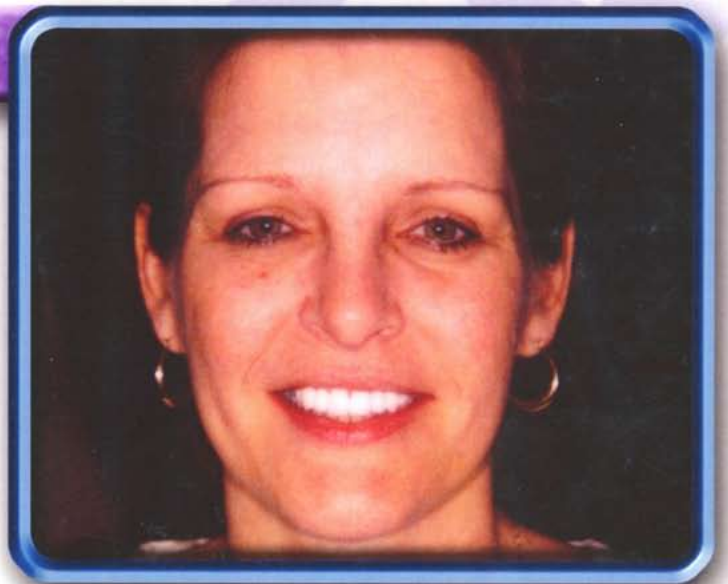
Because the teeth hold-up the lower third of our face, it's important to have the proper tooth length. When the teeth are the proper length/width the face is supported, the lips filled out and some wrinkles will go away or become less noticeable. Total treatment in two weeks.

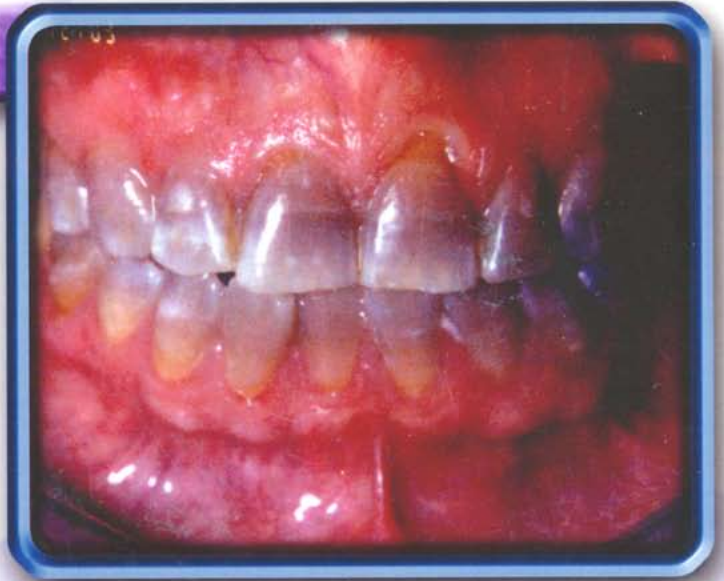
Dark Tetracycline stained teeth, worn teeth, limited budget.

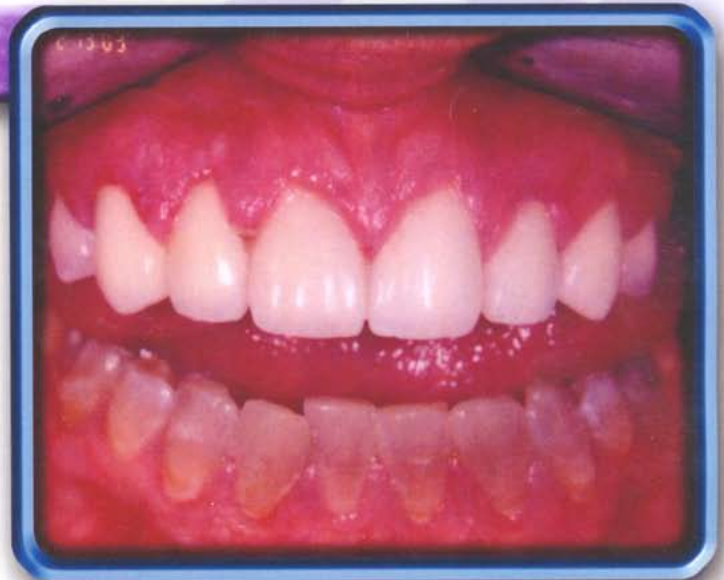
The patient chose to treat eight teeth, which was most of her smile, she has the choice to complete more teeth later. The patient chose a very bright white color ceramic, this was a life changing treatment for this patient.

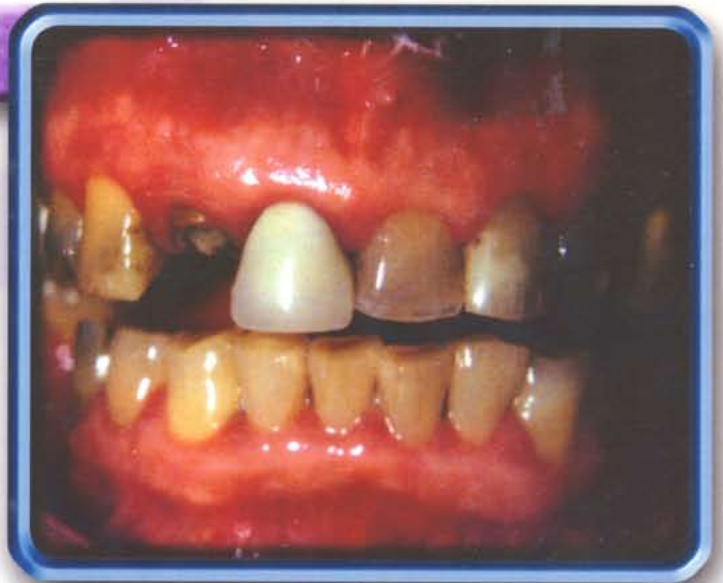
Broken, decayed and missing teeth.

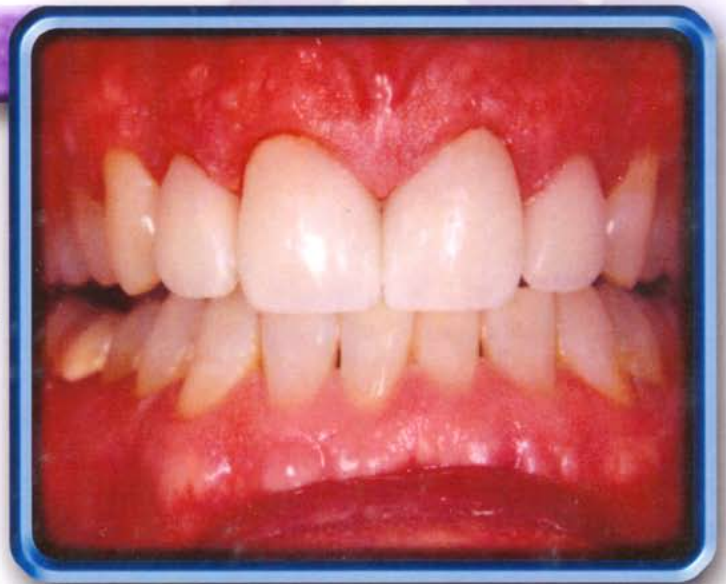
In this case this gap was closed by treating just four teeth with ceramic restorations, many gap closures require a minimum of eight to ten teeth to close gaps. This picture was taken at placement two weeks after initial appointment.

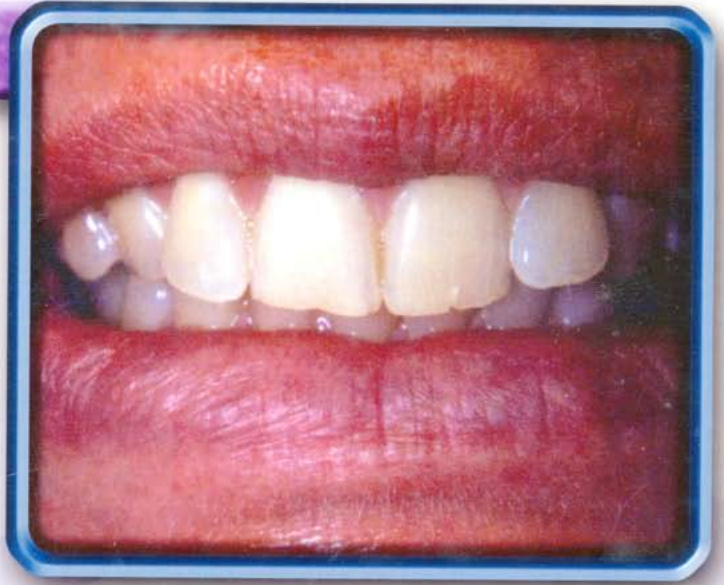
Dark yellow teeth, worn teeth, teeth out of position. Notice forced smile lip positions.
